NASA CR135010

QUIET CLEAN SHORT-HAUL EXPERIMENTAL ENGINE (QCSEE)

Composite Fan Frame Subsystem Test Report

September 1977

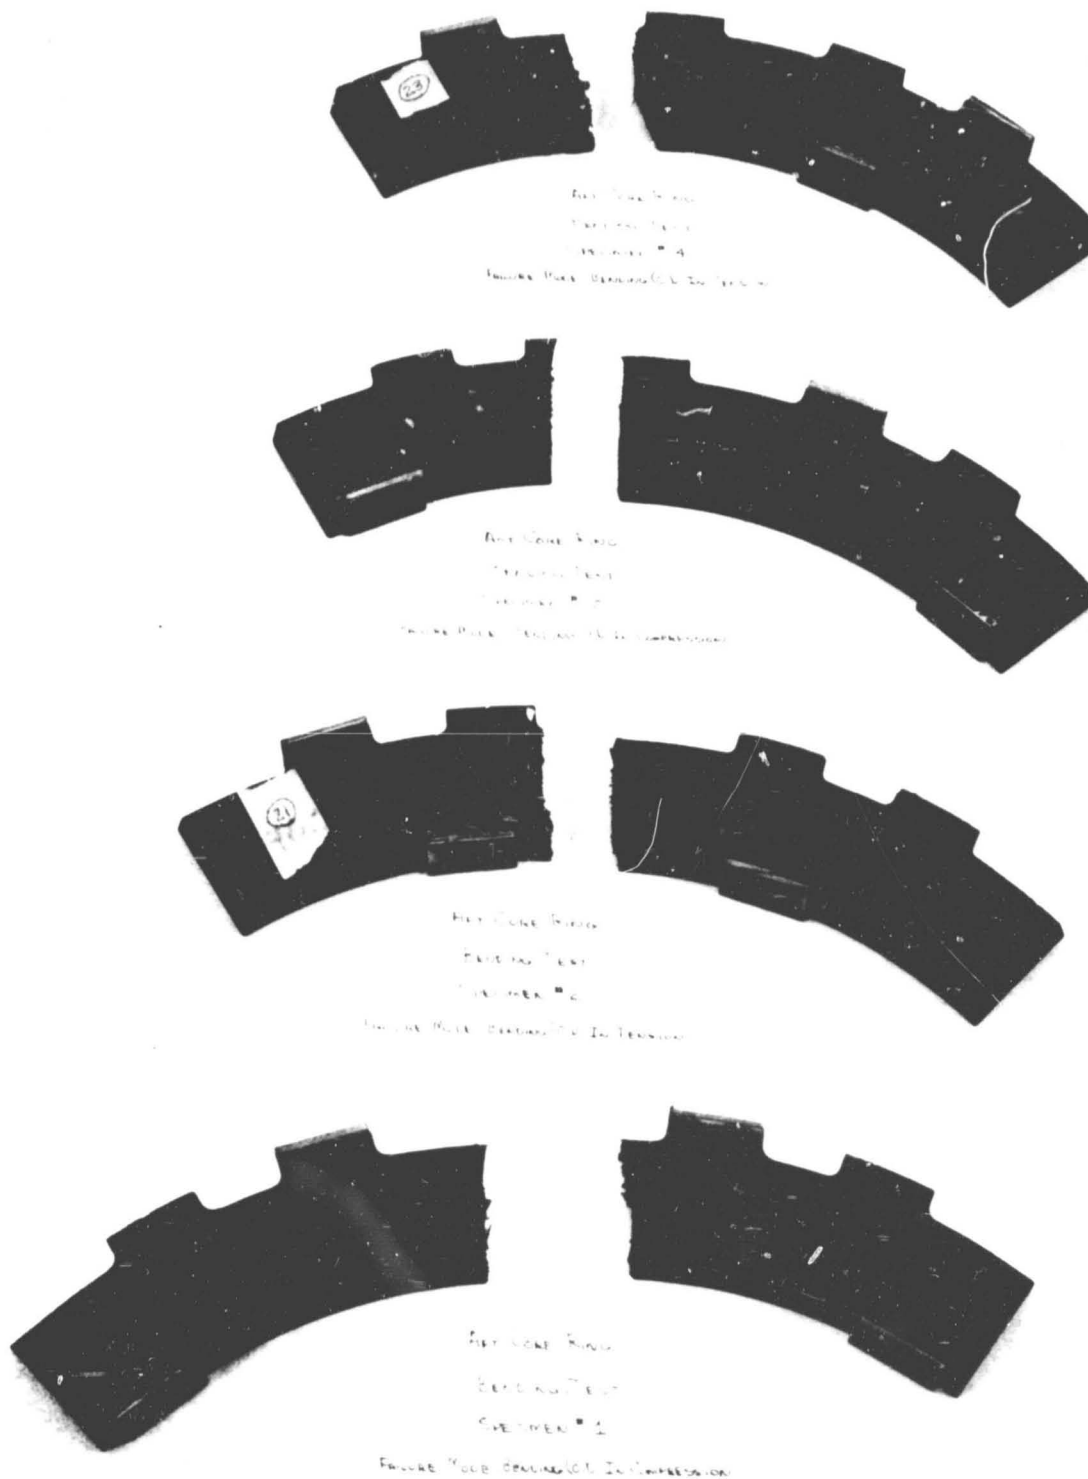
Pictures of the test specimens, after test, are shown in Figures 9 and 10. The lack of uniformity in the test results of the specimens which were tested with the OD in tension {two failed at approximately 151,200 N (34,000 lb) and two failed at 201,950 N (45,400 lb)} led to a thorough investigation of the specimen manufacture, geometry, and mode of failure.

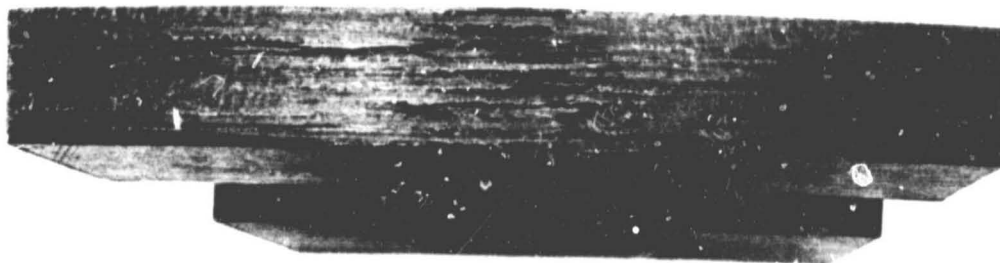
Figure 14. End View of Shear-Out Failures.

1. Core Forward Strut/Ring Joint - Two core spoke specimens representative of the ring/strut joint in the forward wheel of the QCSEE frame were tested and failed at an average load of 221,700 N (49850 lb) which was considerably higher than the required load of 177,900 N (40,000 lb) but less than the tensile capability of the spoke. The mode of failure was a shearing out of the radial spoke plies from the circumferential ring plies (see Figure 14). In order to improve the load capability of the joint, the ply sequence (not orientation) was changed to reduce the number of adjacent plies oriented in the same direction. For example, the portion of the layup that was $(90^\circ_3, 45^\circ, 0^\circ, -45^\circ, 0^\circ_2)$ became $(90^\circ, 0^\circ, 45^\circ, 0^\circ, 90^\circ, 0^\circ, -45^\circ, 0^\circ, 90^\circ, 0^\circ)_s$.³ Test specimen Fwd No. 3 (Table VIII) was constructed and tested using this revised ply sequence. This specimen produced a tensile failure in the spoke as desired. A typical plot of load versus strain for a forward spoke test specimen is shown in Figure 15.

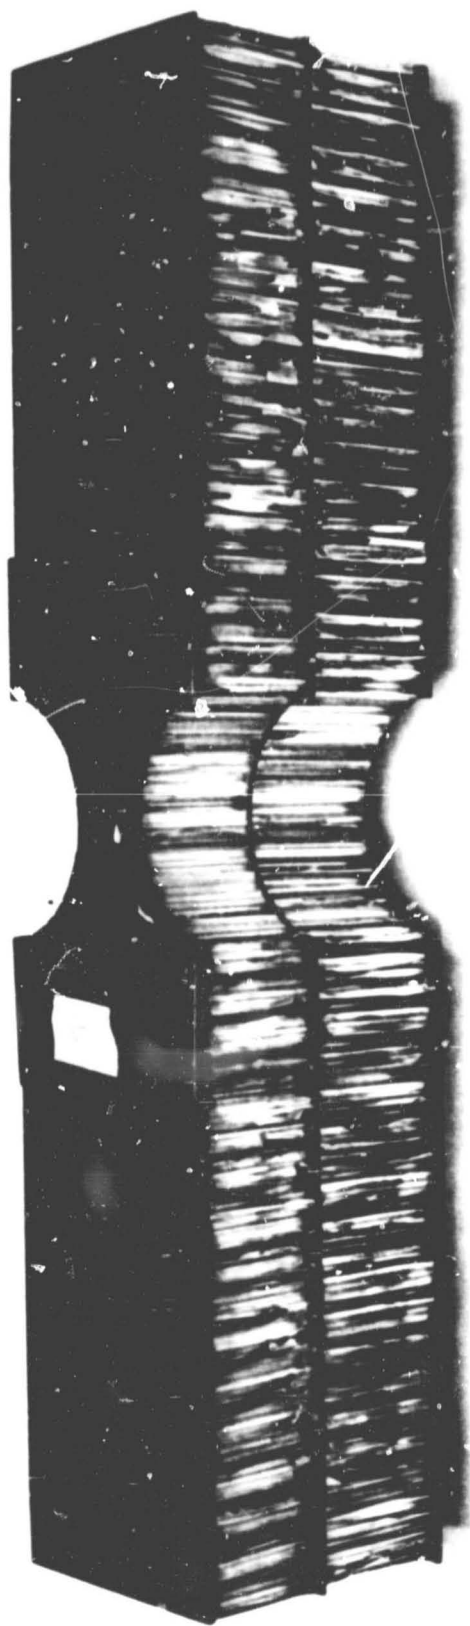
The two remaining panels were then modified into a dogbone configuration to reduce the cross section in the test area. The panels were then tested in four-point bending with the failure occurring in the acoustic face sheet at 13390 N (3010 lb) (tension) and 15520 N (3490 lb) (compression). The corresponding stress at failure is 31270 N/cm² (45,350 psi) (tension) and 36240 N/cm² (55,555 psi) (compression). A picture of one of the failed specimens is shown in Figure 27. A plot showing load versus measured deflection is shown in Figure 28.
